Portage Creek Sediment Remediation Project Kalamazoo, Michigan

Pre-Sediment Removal Structure Feature Assessment
Removal Areas SA1-A, SA1-B and SA1-C

F&V Project Number: 809930
May, 2013

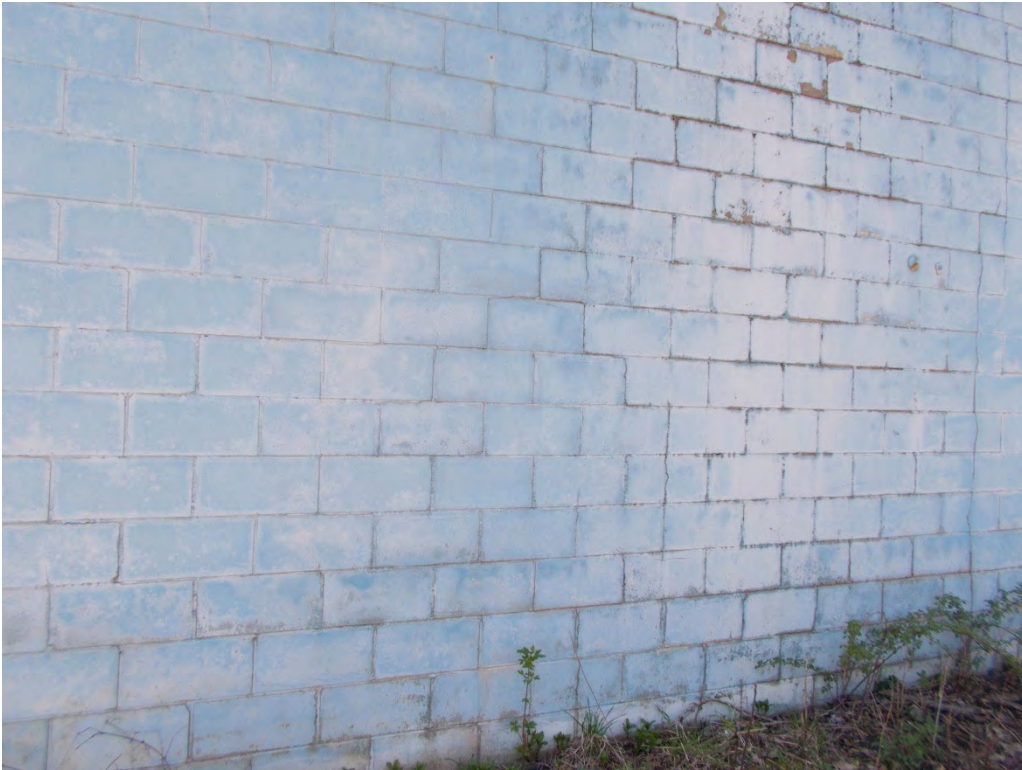
- The CMU has moderate vertical and step cracking.
- A severe vertical crack was noted at the joint between sections of the building.

Step cracking in CMU

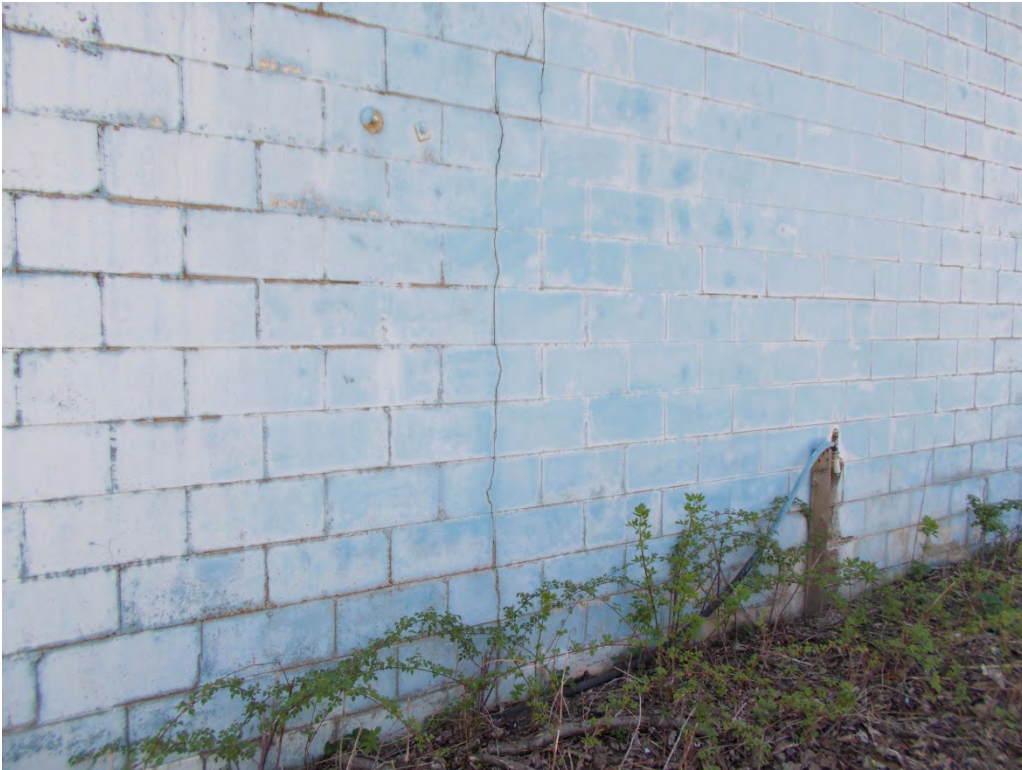
Vertical cracking in the CMU

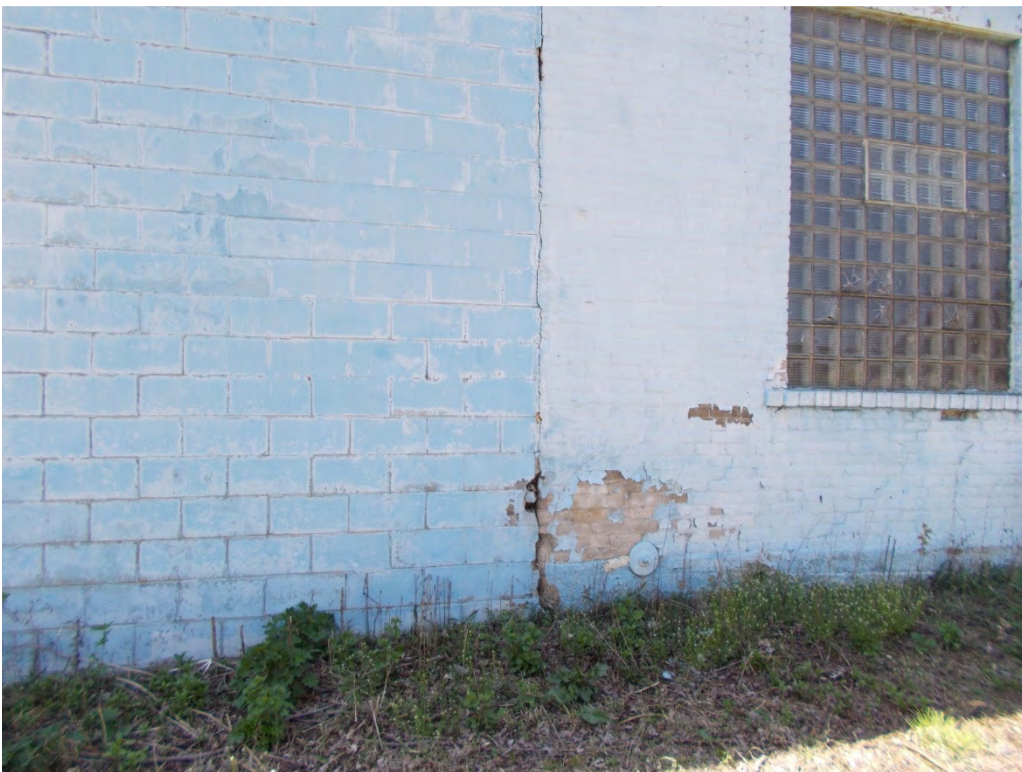
Severe vertical crack at joint between building sections

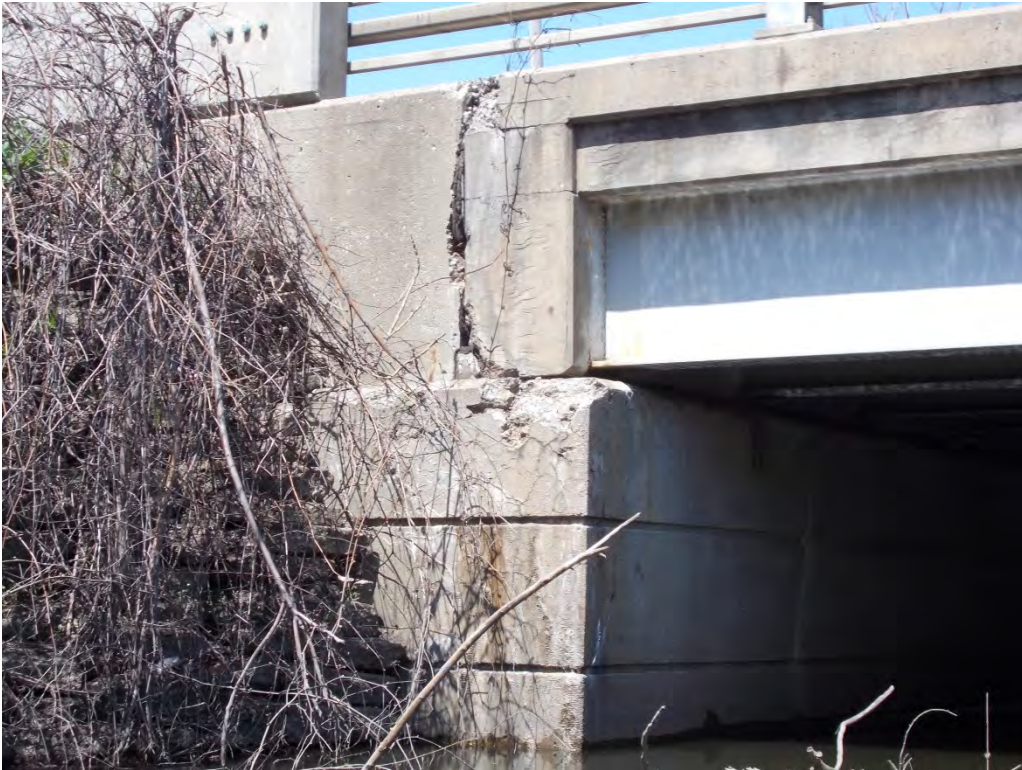
- The channel spans from abutment to abutment. There is no bank intact at the structure.
- The corners of the abutments have cracking with efflorescence and spalling.

Cracking with efflorescence and spalling on southwest abutment

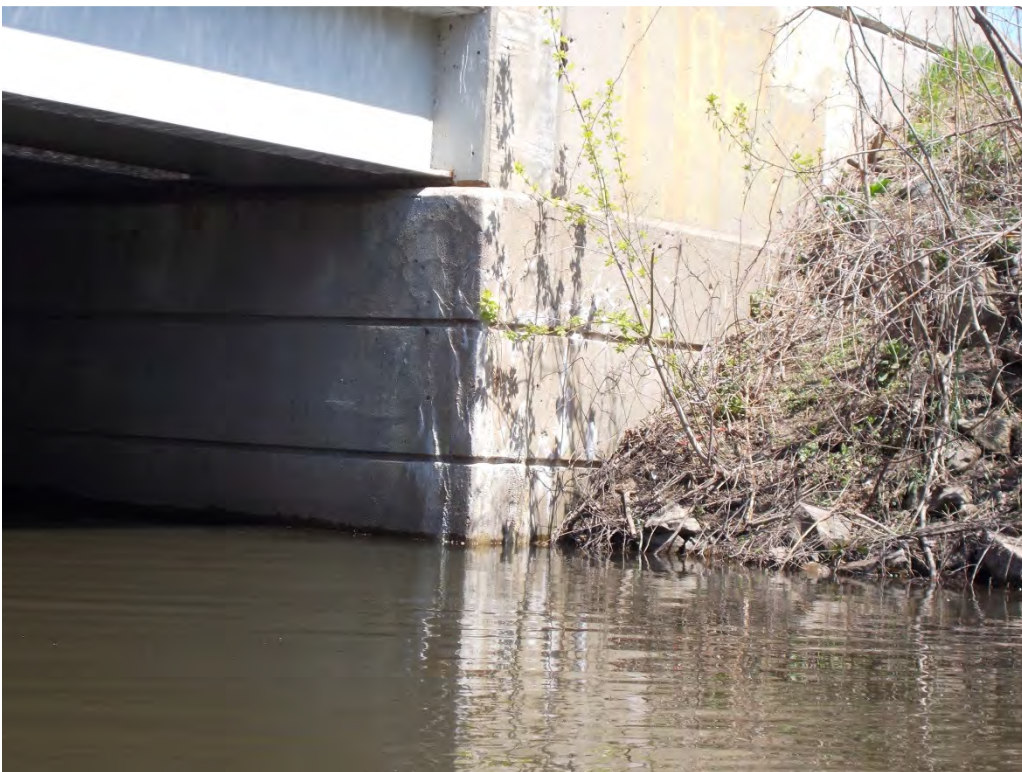
Cracking and efflorescence on southeast abutment

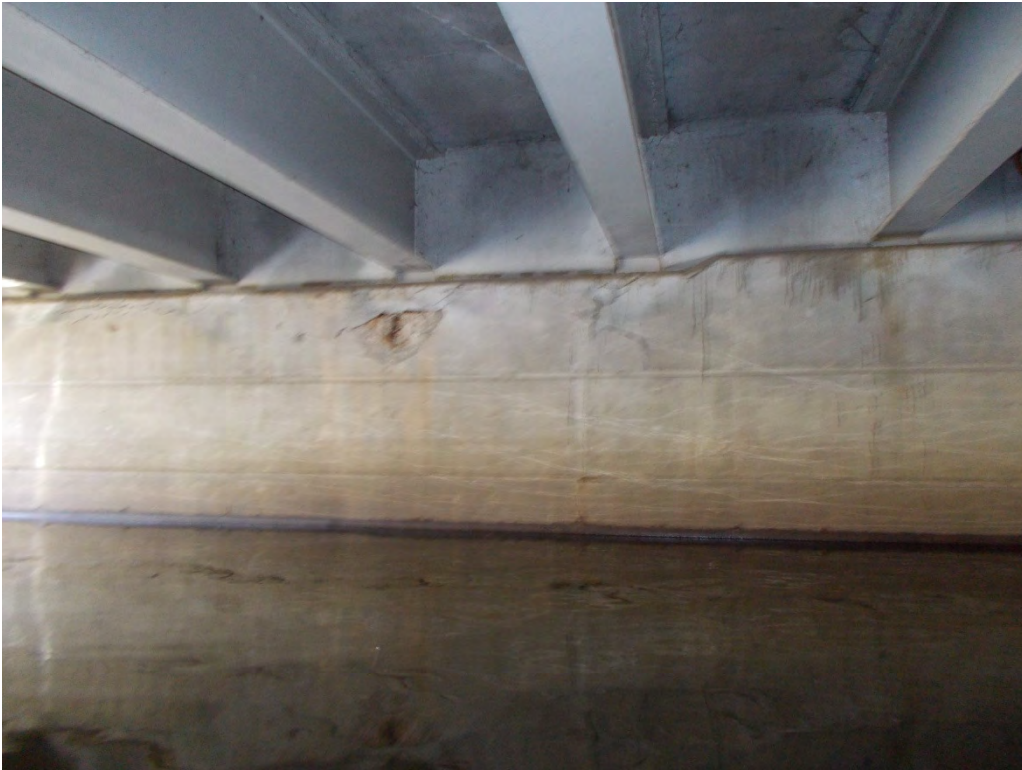
- Moderate slope/bank erosion was noted in all 4 quadrants, severe in the northwest.
- The abutments have minor to moderate vertical cracking scattered throughout. There is an isolated spall to steel beneath beam 4S on in the southwest. The top of abutment is cracked and delaminated between beams 1S and 5S in the southwest.

Spalling with exposed steel beneath beam 4S on west abutment

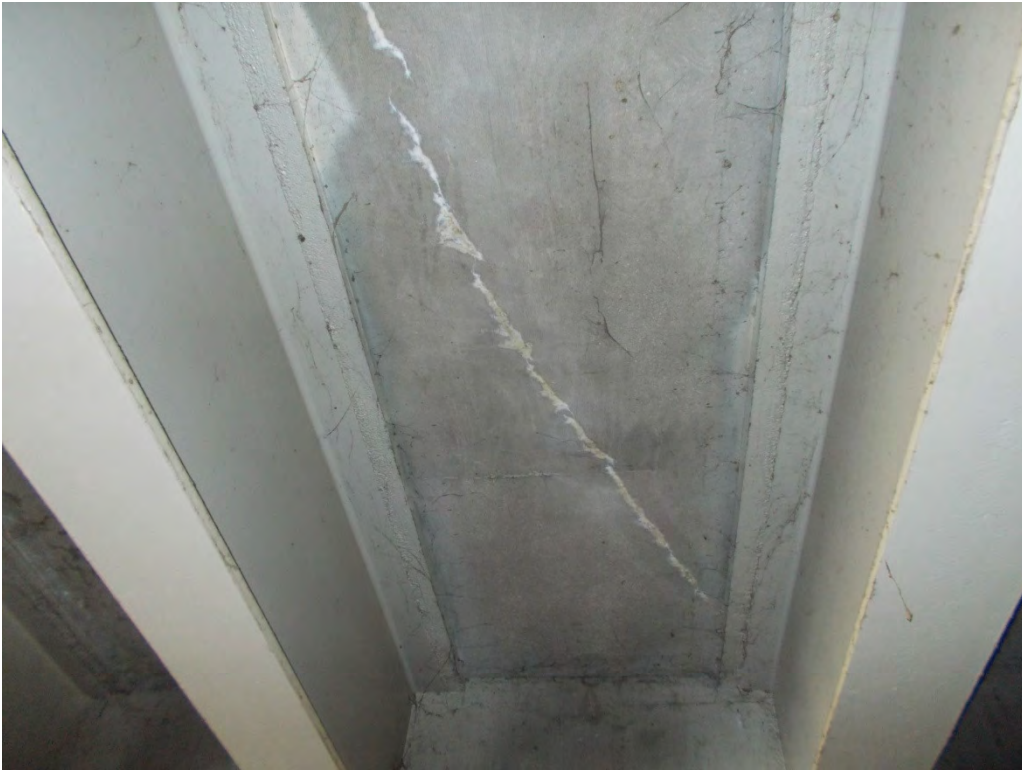
- The deck soffit has scattered hairline longitudinal cracking with efflorescence.
- Scattered riprap was detected along the abutments below the waterline.

Hairline cracking with efflorescence on bottom of deck

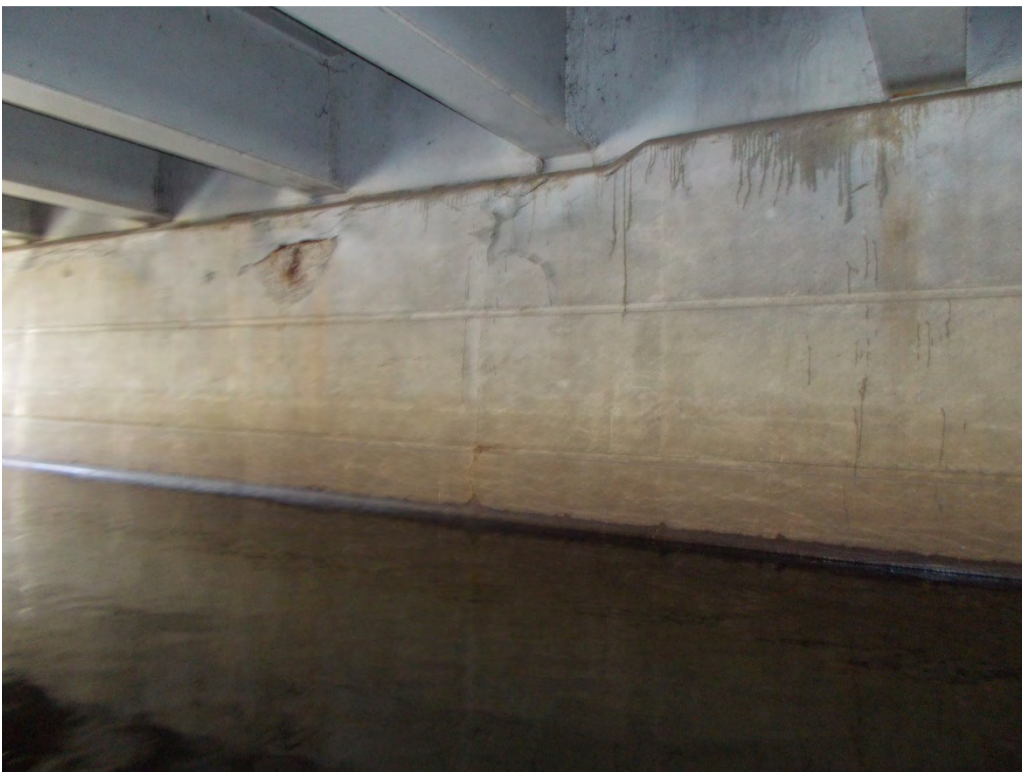
Cracking and delamination on top of abutment in southwest

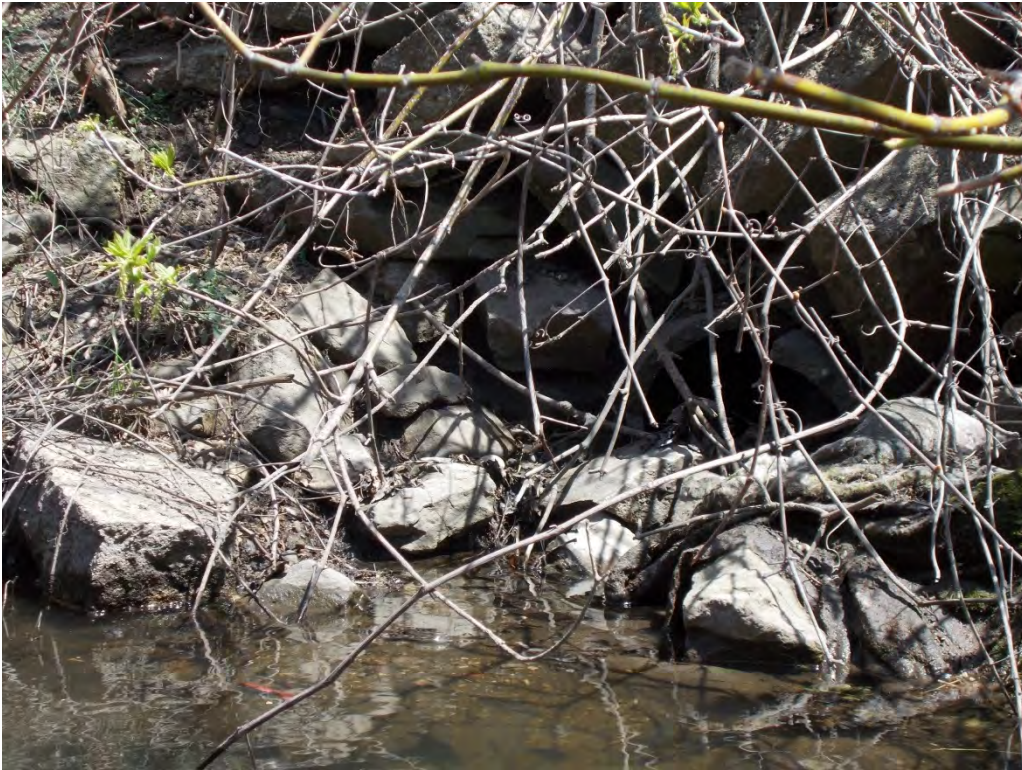
- There is a 12" concrete outlet in the southeast quadrant. The end of the pipe has severe cracking and spalling. Based on the City of Kalamazoo's mapping, there are outlets in all 4 quadrants, however, not all were located.

Concrete outlet pipe in the southeast

- The 12" storm sewer outlet in the southeast should be isolated with a cofferdam during sediment removal. A minimum clearance of 2-3' is recommended for the cofferdam. Other outlets encountered should be protected similarly.
- Because the bridge is supported on spread footings, which are more susceptible to vibration and settlement than structures on deep foundations, a minimum clearance of 6-8' is recommended for sheet pile cofferdams near the structure.
- Utilize Miss Dig Flagging to confirm the location of gas, electric, force main and water main in the area of the structure prior to installing any cofferdam structures. Maintain a minimum of 4-6 feet clearance with any sheet pile cofferdams or as directed by the utility.

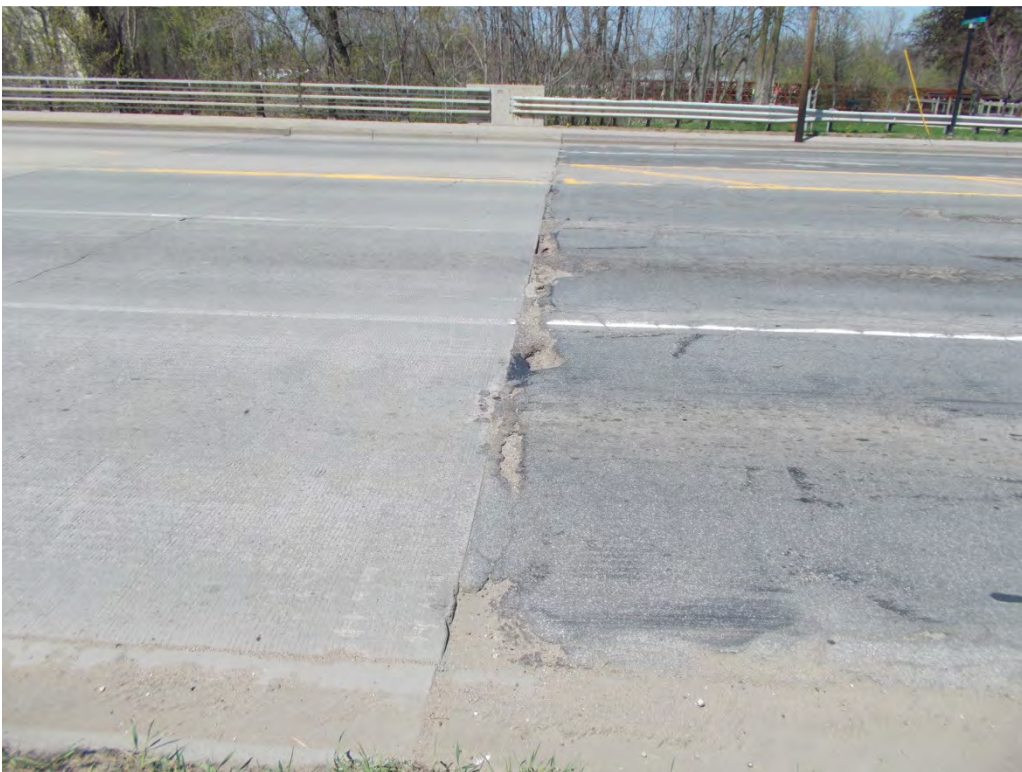
- The decorative street light in the northwest quadrant has sustained damage to its base.
- The asphalt pavement beyond the concrete approaches is severely deteriorated with significant cracking and spalling/cold patch.

Deterioration of the asphalt pavement along the east approach slab

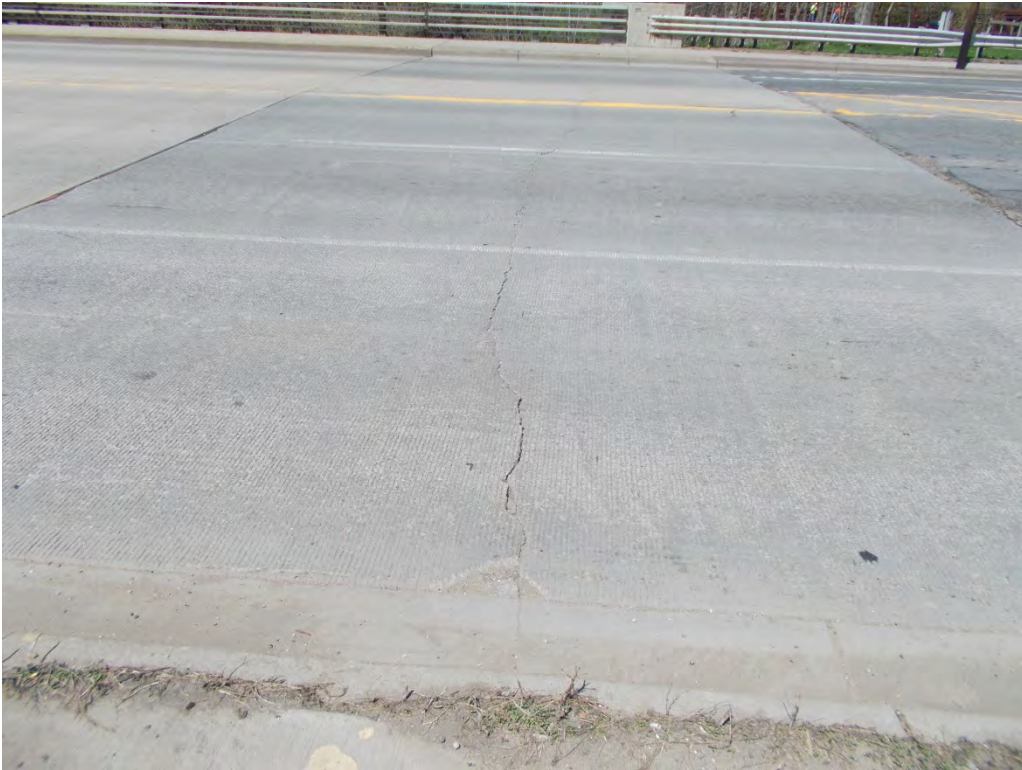
- Scattered woody debris was noted in the channel.
- The concrete approaches have severe transverse cracking.
- ASR-type cracking was noted in the railing end walls.

Transverse cracking in the east concrete approach slab

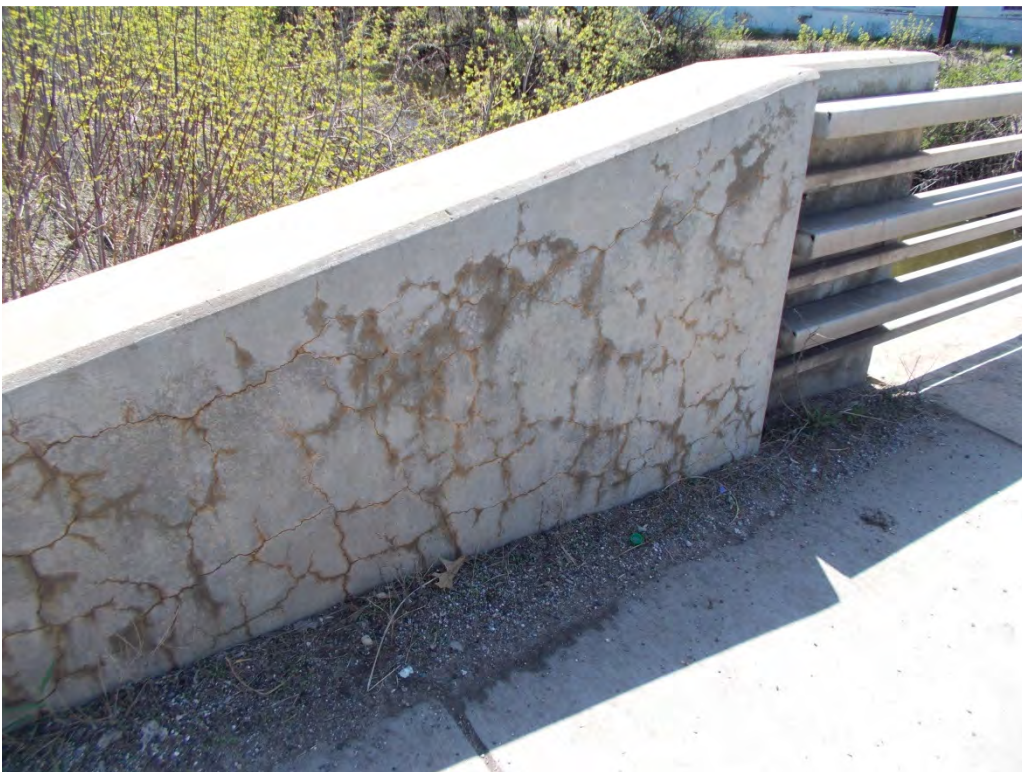
ASR-type cracking in the southeast end wall

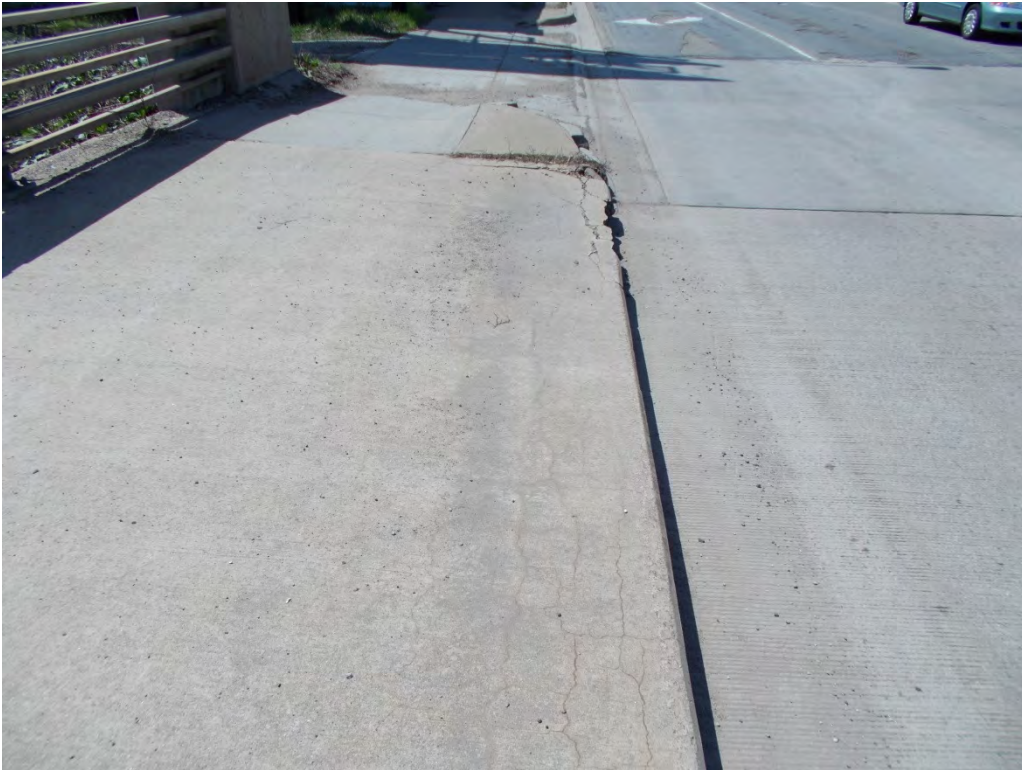
- Hairline map cracking was noted in the sidewalk beneath the railings. The sidewalks have scattered hairline to minor map cracking.
- There is an area of severe curb/sidewalk spalling in the southwest.

Cracking and spalling of southwest curb/sidewalk

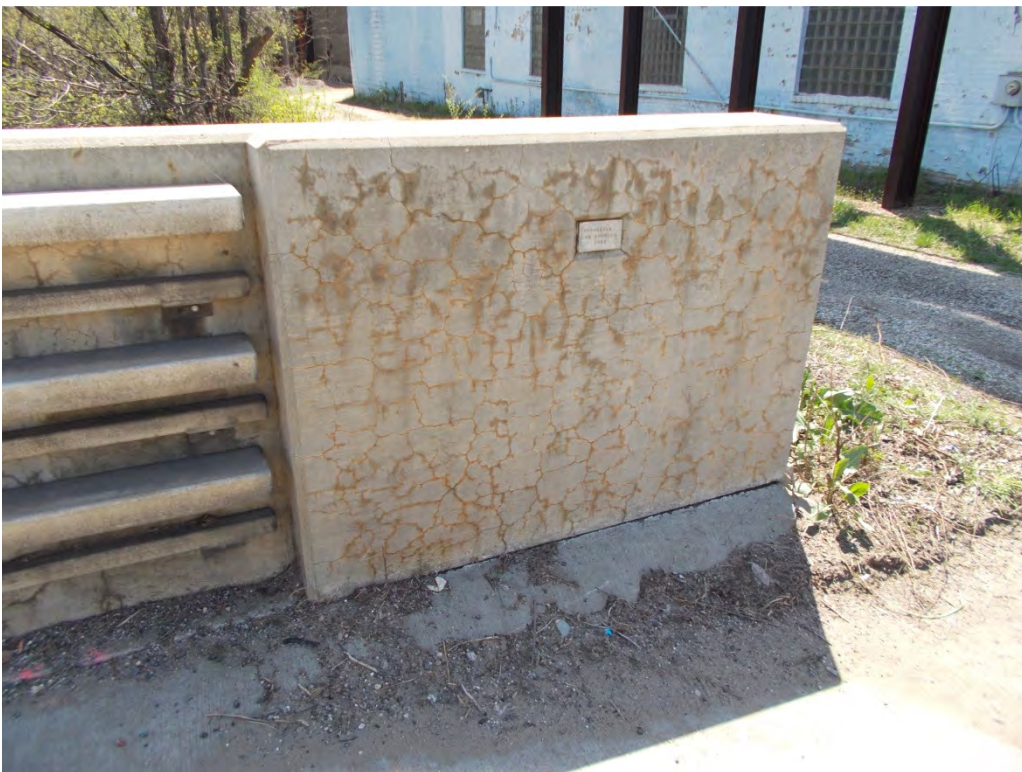
ASR-type cracking in the southwest end wall

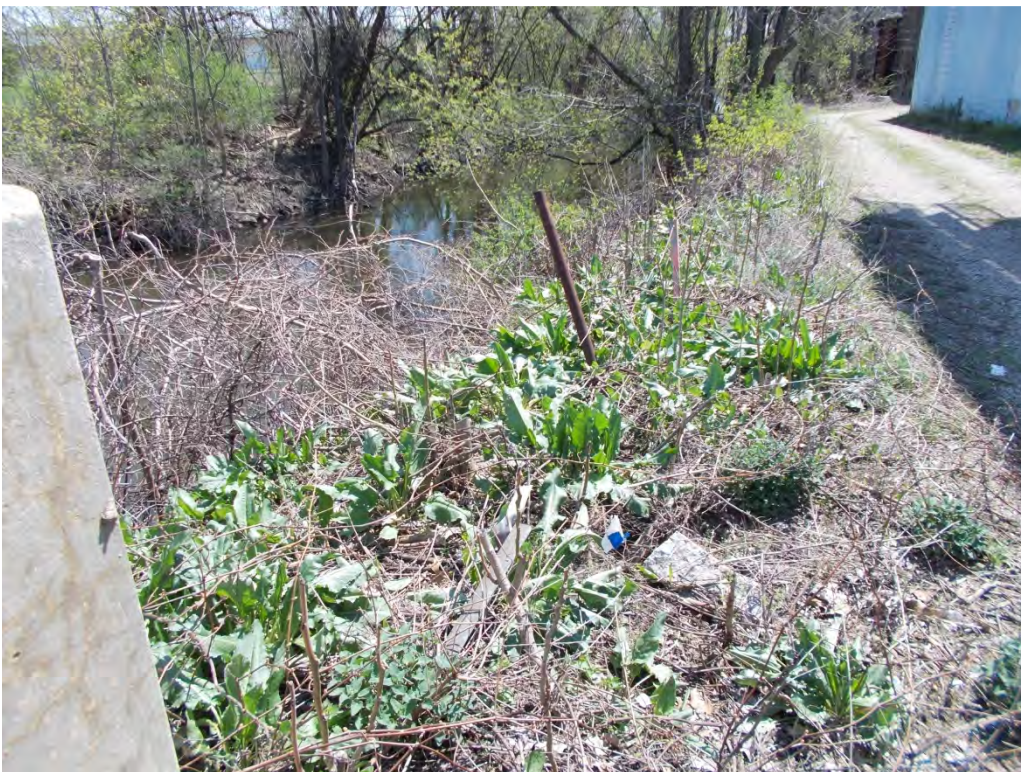
- The deck has an isolated area of spalling, approximately 12"x18" along the west reference line near centerline.
- There is a failed cable railing in the southwest.

Failed cable railing in the southwest

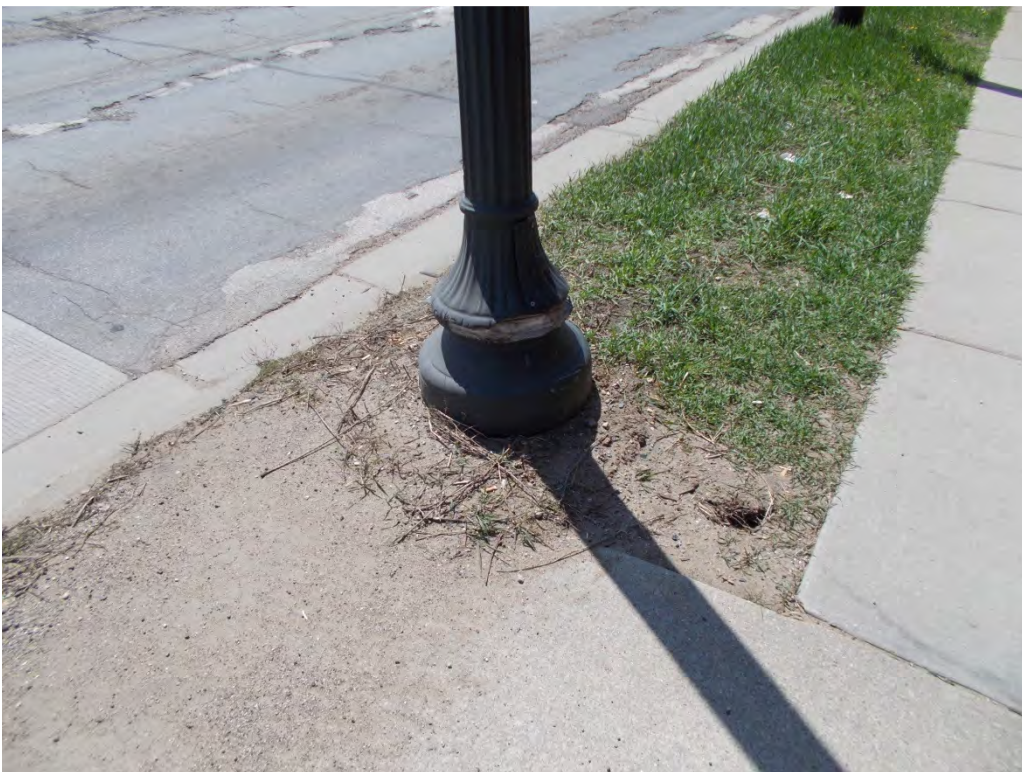
Damaged area of light base in the northwest

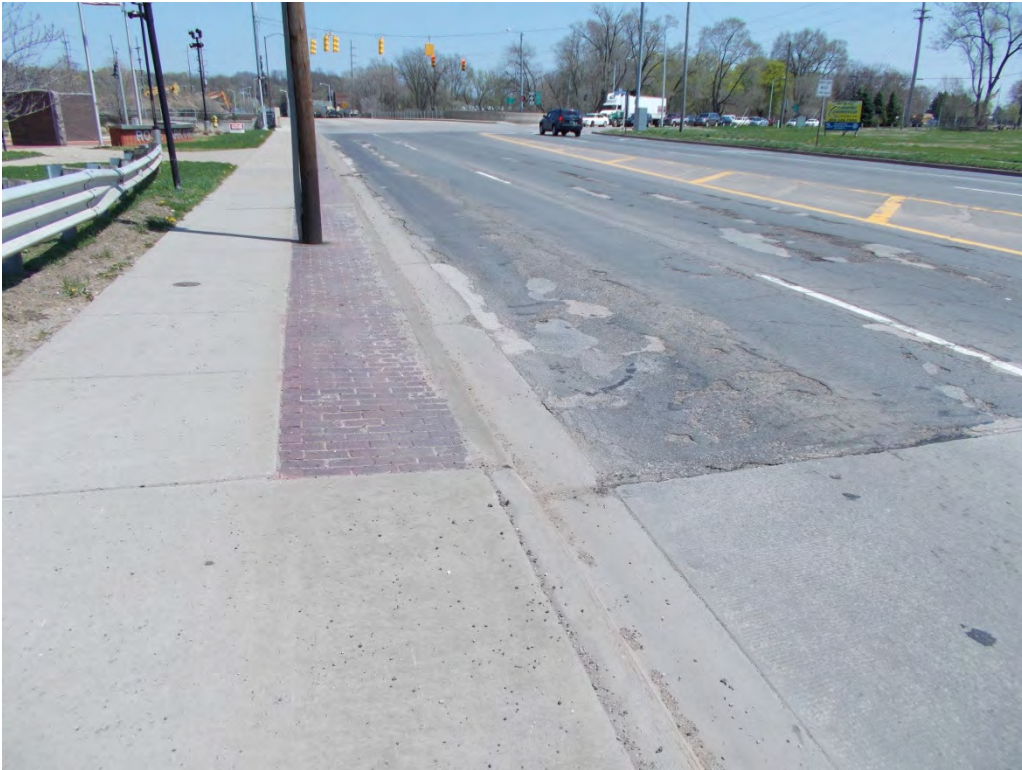
Decorative pavement in the northeast and deterioration of asphalt pavement

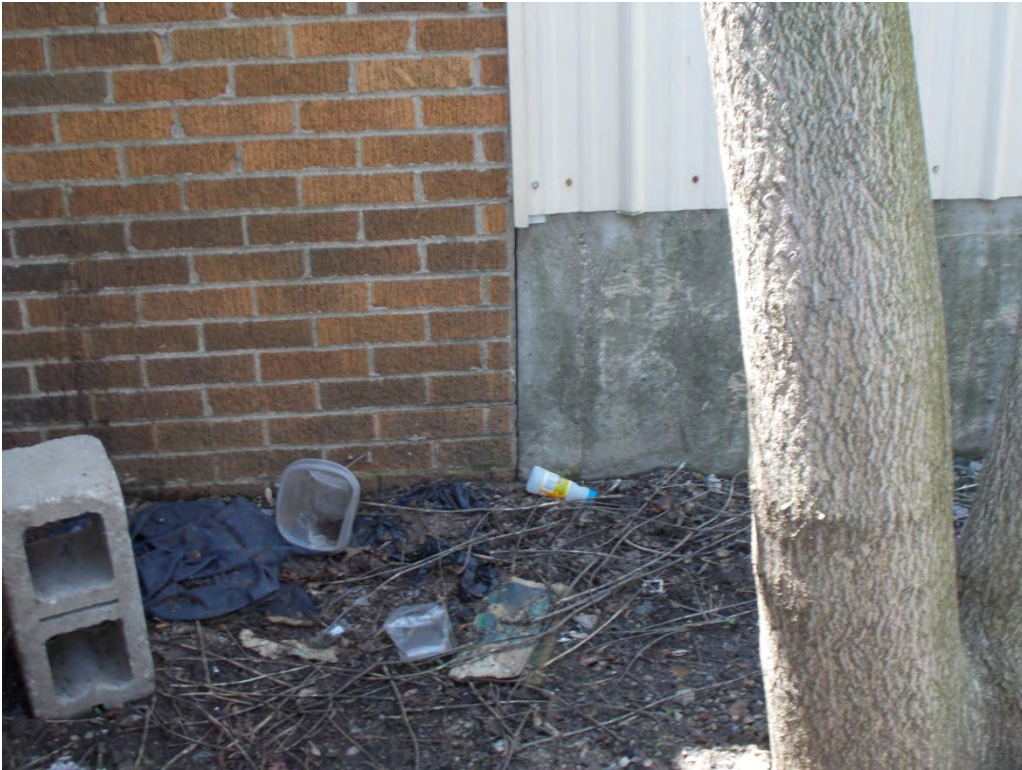
Joint separation between brick and concrete foundation wall

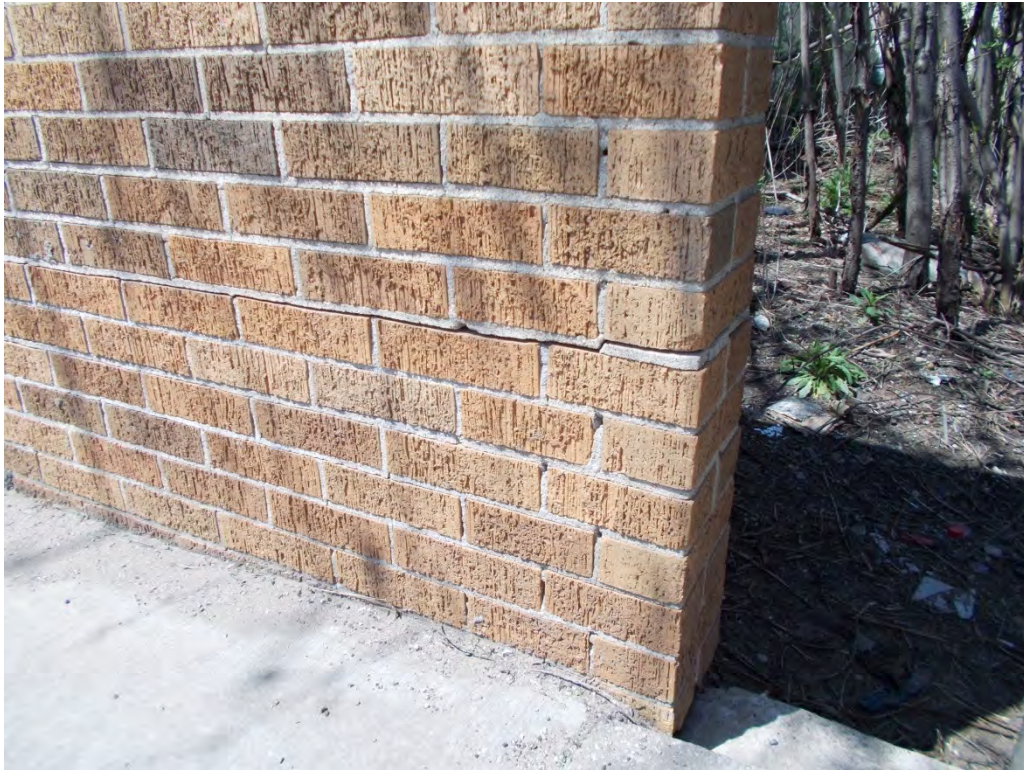
- The brick extension wall in the southeast corner has severe horizontal cracking at a mortar joint.
- The concrete foundation appears to be in fair condition.
- The aluminum siding appears to be in fair condition.
- The wood window trim is severely rotted.
- A significant amount of brush growth was noted behind the siding.
- The concrete and asphalt pavements on the north side of the building are severely deteriorated. The asphalt in particular has failed, apparently due to dumpster access.

Horizontal cracking in southeast extension wall

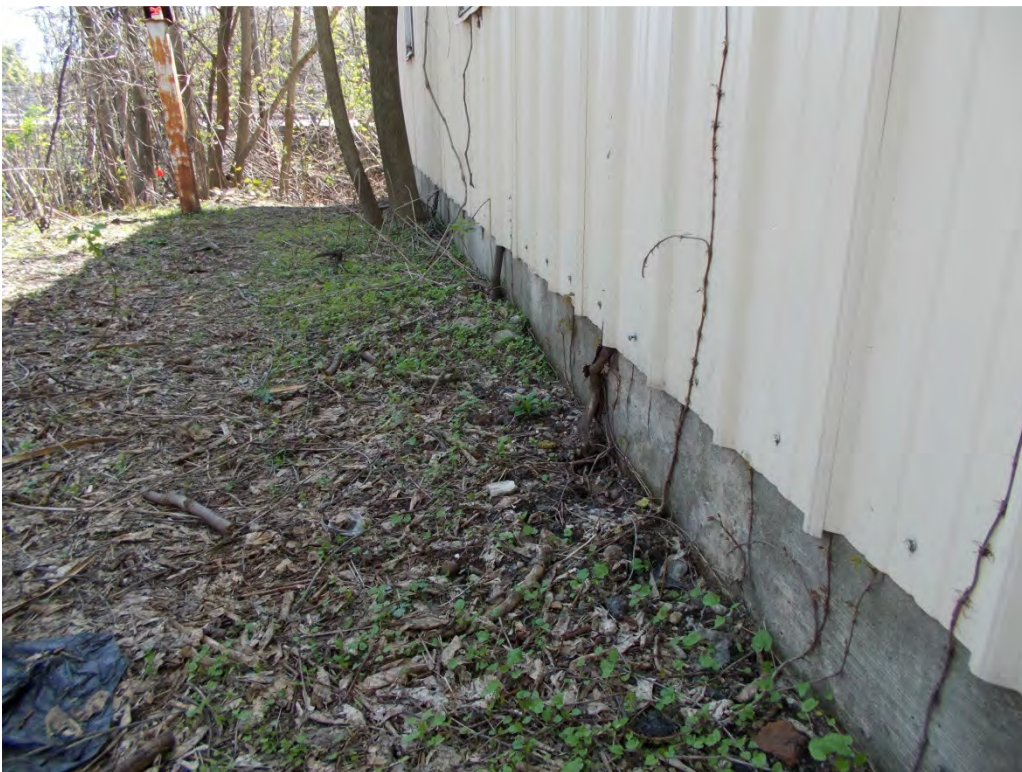
Brush growth behind aluminum siding

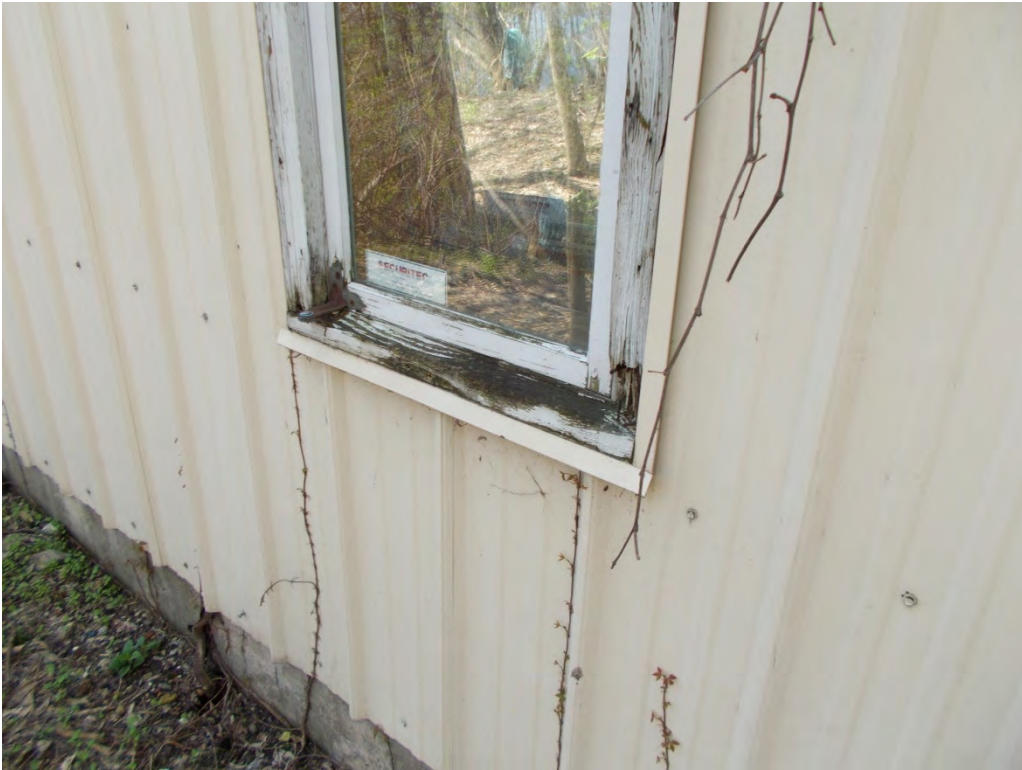
Severe rot on window trim

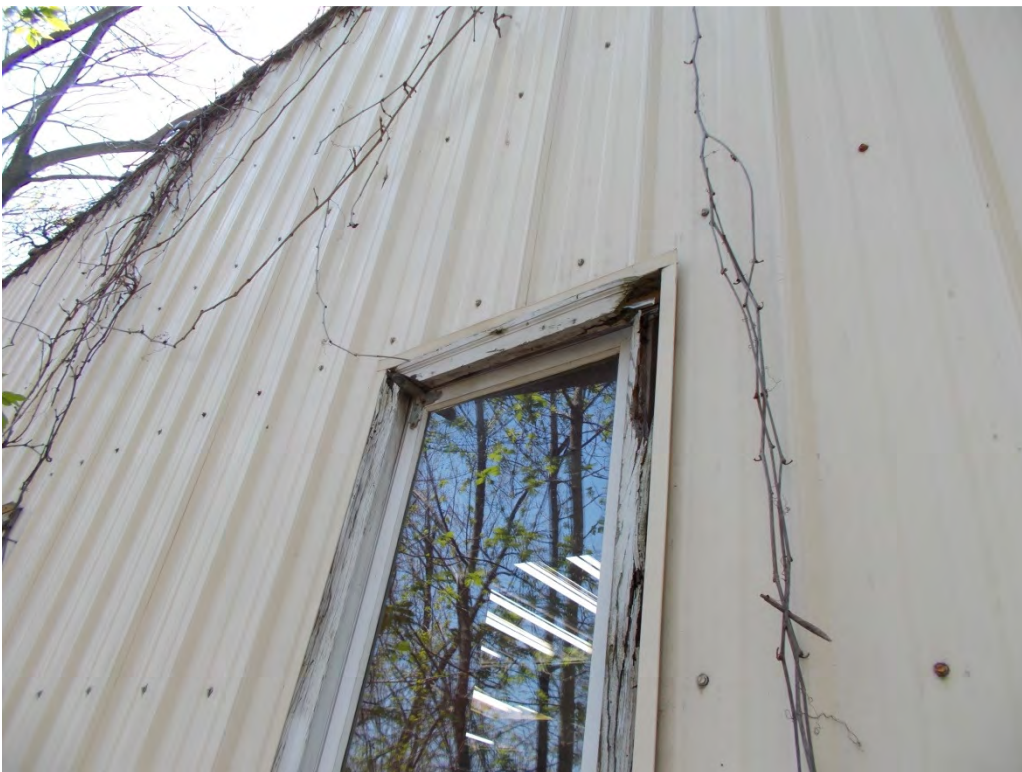
Severe rot on window trim

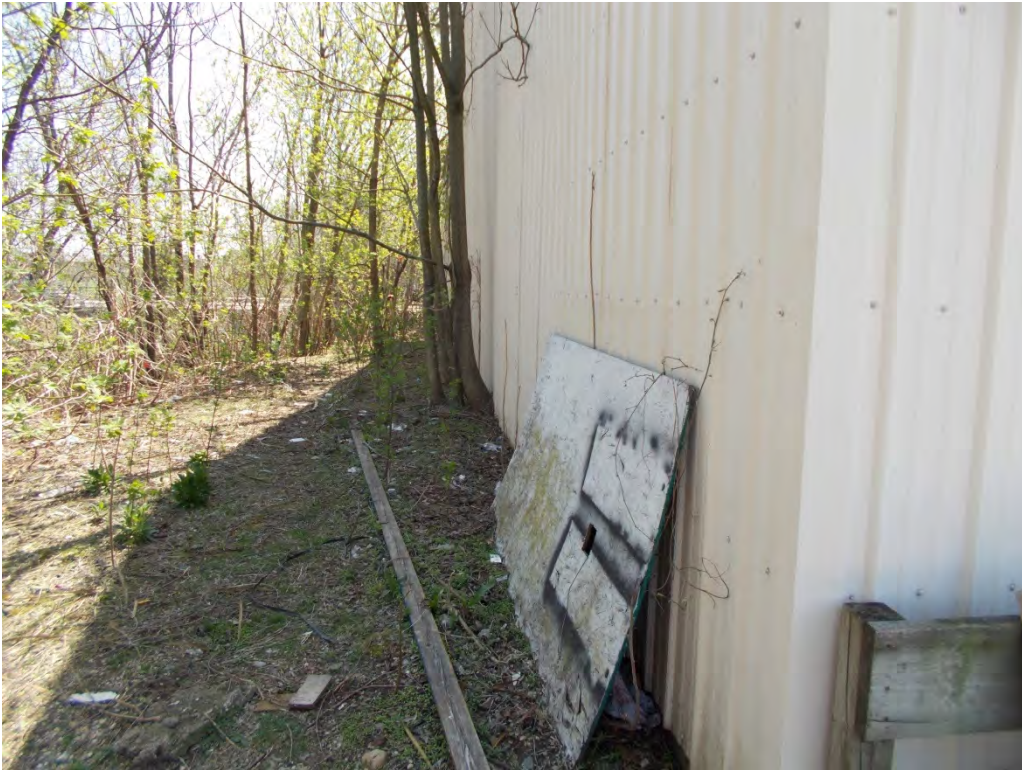
Tree growth along northeast wall

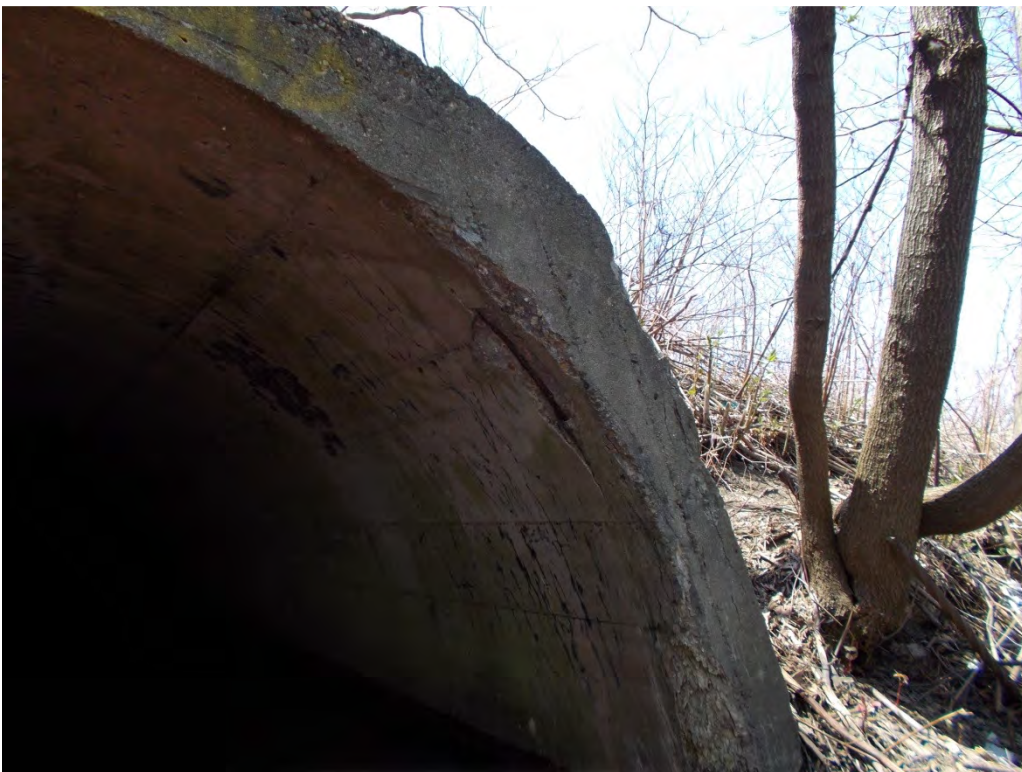
- There is a spalled area with exposed steel on the north side of the interior.
- The concrete has efflorescence and delamination along the waterline.
- Minor to moderate cracking was noted in the soffit area.
- The majority of the structure appears to be in fair condition.
- Assuming the structure is a complete circular section, the invert of the pipe appears to be approximately 2-3 feet below the bottom of the channel.

Spalling with exposed steel on the northern interior

- The structure should be isolated from the creek during sediment removal to allow for dewatering. A minimum clearance of 3-4 feet is recommended for a sheet pile cofferdam, if that is the selected method of isolation.

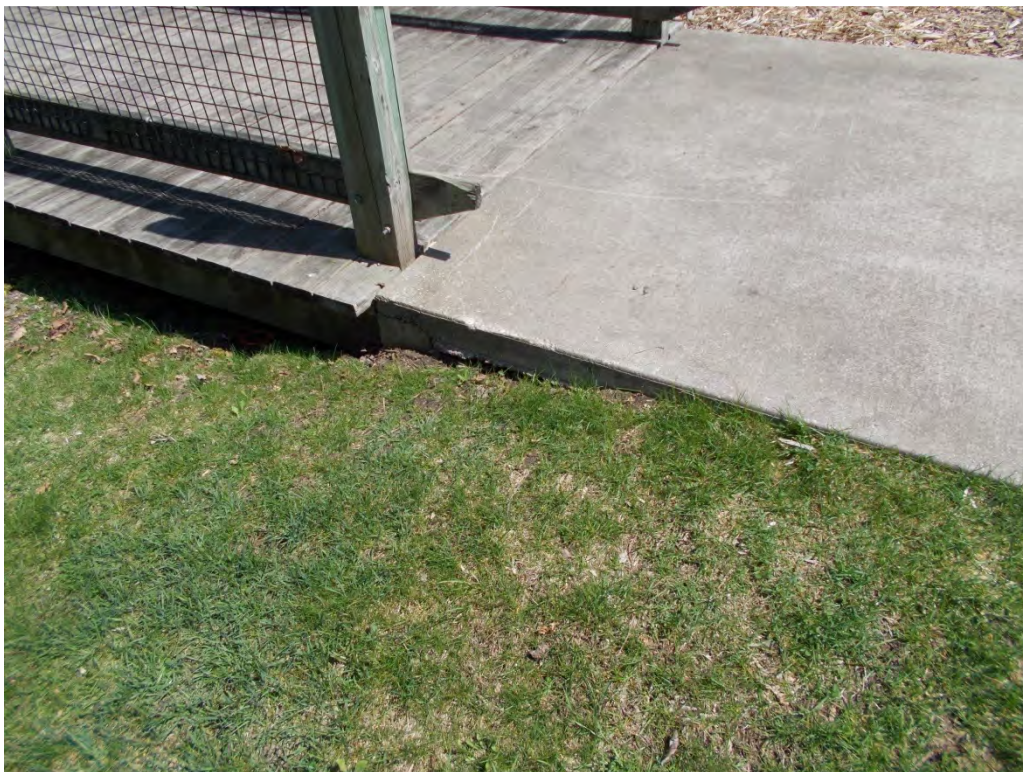
- The timber decking is weathered and has minor splitting over most of its area.
- Field stone riprap is in place around both abutments.
- The concrete sidewalk connecting to the boardwalk in the southeast is undermined approximately 2" and has cracking near its end.

Undermined and cracked concrete sidewalk in the southeast

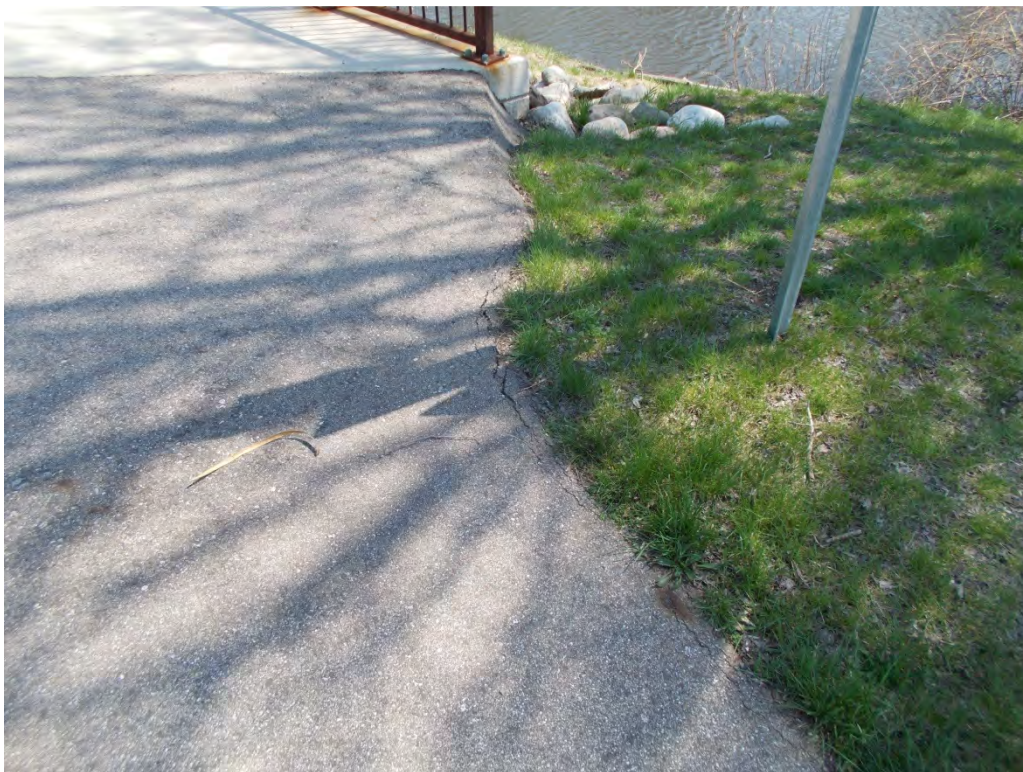
- Brush growth is encroaching on the southeast quadrant of the structure.
- The asphalt/concrete joint on the west approach is opening slightly. The asphalt has an isolated area of edge cracking in the southwest.

Edge cracking in the southwest asphalt approach area

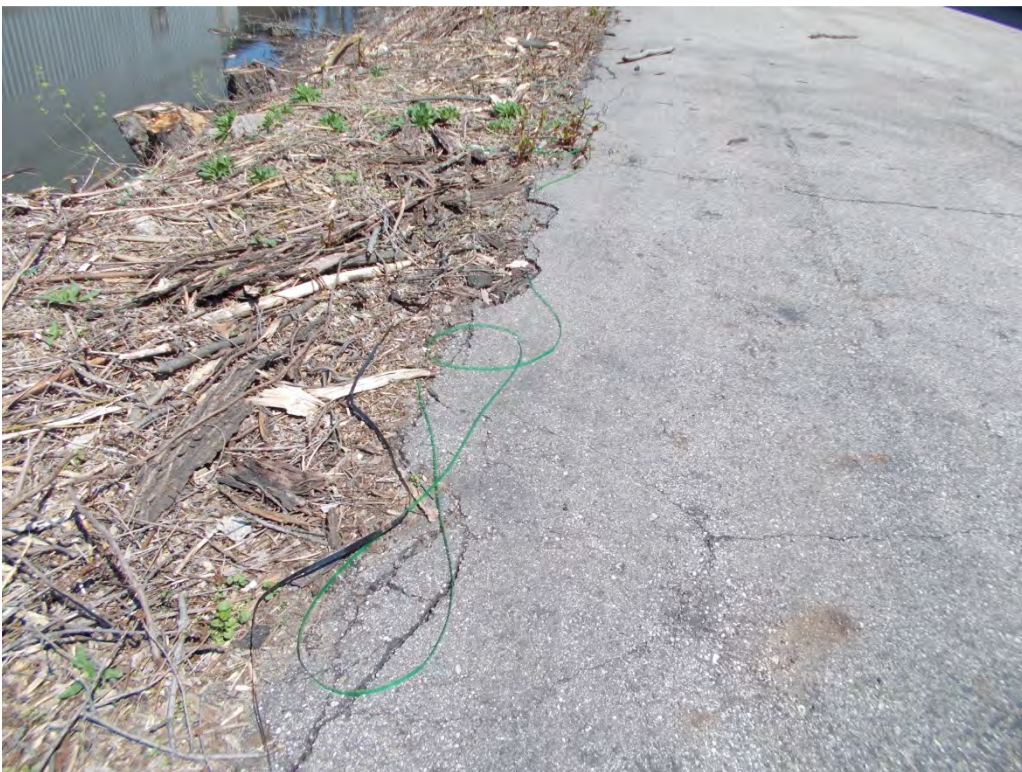
- The asphalt pavement is in fair to poor condition with cracking throughout, some of which has vegetation growth.
- Severe edge cracking and spalling was noted.
- Several areas of settlement and alligator cracking were noted.
- There is a concrete bumper at a commercial dumpster near the north end of the pavement area.

Edge cracking and spalling

- Repair or replace damaged areas of pavement as required.
